# YIELD MECHANISM OF PERFORATED PLATE CONNECTIONS FOR MASS TIMBER SYSTEMS

**ABSTRACT:** Mechanical connections are often the only source of ductile behaviour in mass-timber systems. This paper presents an experimental study on using perforated steel plates as a dissipating energy device, also called a seismic fuse, to enhance the structural performance of mass timber systems during extreme loading events. A target application of the perforated plate connection is in braced timber frames. Six perforation patterns were developed based on preceding experimental and numerical studies and tested under cyclic loads. These different patterns targeting one or multiple yielding mechanisms: shear, axial (tension and compression), and bending. The hysteresis performance and failure mechanism of the perforated plate systems showed that the selected patterns provided reliable yield mechanisms and that damage to timber elements can be avoided when the fuses are combined with capacity-protected dowel-type fasteners. In addition, the results of cyclic tests demonstrated sufficient ductility and ultimate displacement for specific patterns, e.g., specimens with long oval perforations, to achieve th

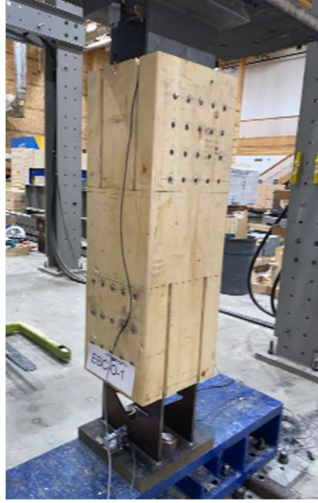
**Figure 3:** Sample specimen: (a) photo, (b) schematic, instrumentation included

As shown in Figure 3 (a), the specimens consisted of fuses and capacity-protected dowel-type connections at one end (bottom) and capacity-protected connection at the other end (top). Fifteen and twenty tight-fit steel dowels of diameter 16 mm were used in the capacity-protected and fuse end connections, respectively. The specimens were instrumented using six Linear Variable Differential Transformers (LVDT), as shown in Figure 3 (b), labelled LVDT1 to LVDT6. The average displacement of the perforation zones was recorded by LVDT1 and LVDT2. LVDT3 to LVDT6 were used to monitor the deformation in the capacity-protected steel dowels.

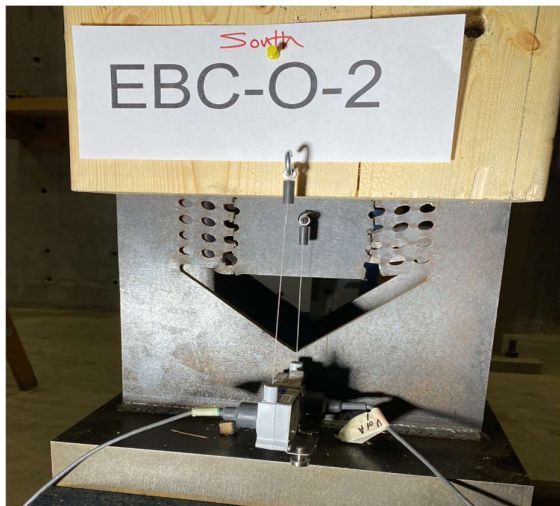
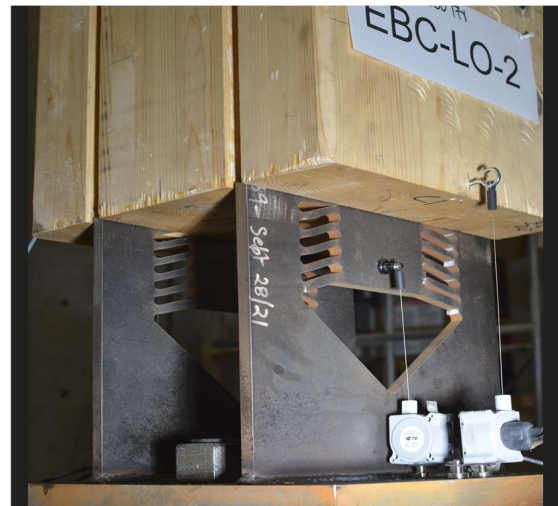
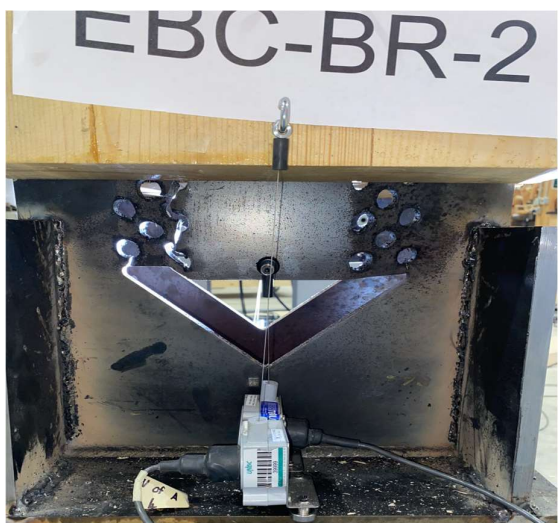
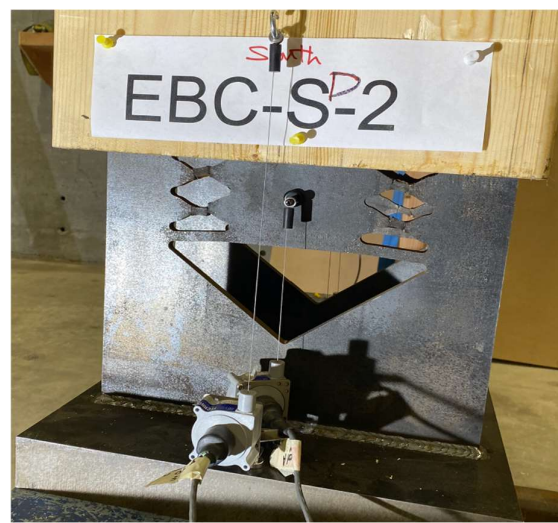
**Figure 4:** Failure modes and deformed shapes

The deformed shape and its corresponding load-deformation hysteresis curves for selected specimens are shown in Figures 4 and 5, respectively. Detailed analysis of the test results is currently in progress at the time of writing this paper. Some preliminary findings and test observations are presented below.

sudden rupture of inner link elements and propagates vertically to other elements in the row. Almost the same failure mode was observed in both replicates; the failure mode of EBC-O-2 is shown in Figure 5 (a). The other rows, while uniformly yielded, did not experience any rupture. Both specimens achieved similar ultimate displacements but different peak loads. The hysteresis curve of EBC-O-2 is shown in Figure 6 (a). As can be seen, the curve is wide, with substantial energy dissipation capability.

Due to a mistake in load application, EBC-S-1 was subjected to a monotonic load and buckled. EBC-S-2 was loaded cyclically, as anticipated; but similarly failed due to the global buckling of the knife plates, as shown in Figure 5 (b). The weak line was found where the perforation ends, and the triangular cut-out is maximized. While global buckling of the plates could be used as a source of energy dissipation, the difference in tensile and compressive responses, as noted in Figure 6 (b), might make it difficult to predict the onset of yielding. The pinching behaviour due to the buckling of the plate in compression is evident. Pattern EBC-S was initially aimed at achieving axial yielding in the perforation zones. The observed buckling behaviour necessitated modifying the perforation patterns to achieve the target failure mode. This led to the buckling restrained specimens of EBC-BR, as discussed below, in 3.3.

EBC-BR contains a larger perforation diameter compared to EBC-S. In addition, four stiff plates were welded to the outer sides of the knife plates. The failure mode of EBC-BR-2 is shown in Figure 5 (c). As can be seen, these two major changes caused the shift in failure mode from global plate buckling to axial yielding of link elements, as intended. The link on the inner rows is mainly ruptured due to excessive yielding, while there were no ruptures observed in other rows, although significant yielding was observed. Figure 6 (c) depicts that this fuse pattern possesses ample wide hysteresis curves, with improved strength and ultimate displacement, compared with EBC-S.

EBC-OS-1, similar to EBC-S-1 and EBC-S-2, globally buckled at the weak line of the minimum cross section. Increasing the size of perforations in EBC-OS-2 shifted the failure mode from global buckling to rupture in the perforation zones, as seen in Figure 5 (d). The intended axial yielding mechanism is achieved in the EBC-OS-2. Also, the pinching observed due to buckling in the hysteresis loops of the EBC-OS-1 faded away in the EBC-OS-2 responses, as shown in Figure 6 (d). The larger perforations also allow an increase in ultimate displacement achieved by the specimen.

The target failure mode for this pattern was flexural yielding, achieved by forming two plastic hinges at the ends of link elements. The two specimens behaved almost the same. Figure 5 (e) shows the failure mode of EBC-LO-2; the outer plastic hinges experienced rupture first in the majority of perforation zones, and then the failure propagated to the inner plastic hinges of the link elements. The hysteresis loops of the two specimens were almost the same; see Figure 6 (e) corresponding to EBC-LO-2, for instance. The results show reasonable ductility for the fuses, with large open hysteretic loops reflecting the ability of the fuse to dissipate energy. Significant ultimate displacements were observed with this pattern compared with other patterns, suggesting that the flexural mechanism, achieved with the long oval-shaped perforations, could be the desired pattern to improve the fuse behaviour under cyclic loading.

Like EBC-LO specimens, the intended yielding mechanism for EBC-SD specimens was also flexural yielding. However, instead of two plastic hinges at the ends of the link elements, a non-prismatic cross section was used to force the formation of the plastic hinges in the middle of the link elements. The intended failure mode was achieved in both specimens; Figure 5 (f) shows the EBC-LO-1 failure mode. Although the hysteresis loops are wider compared to the EBC-LO pattern, limited ultimate displacement caused the dissipative energy capability of the fuse to be insignificant, see Figure 6 (f). However, the hysteresis behaviour of the fuse, in terms of the area enclosed per cycle, looks promising and may be enhanced with minor revisions in the future.

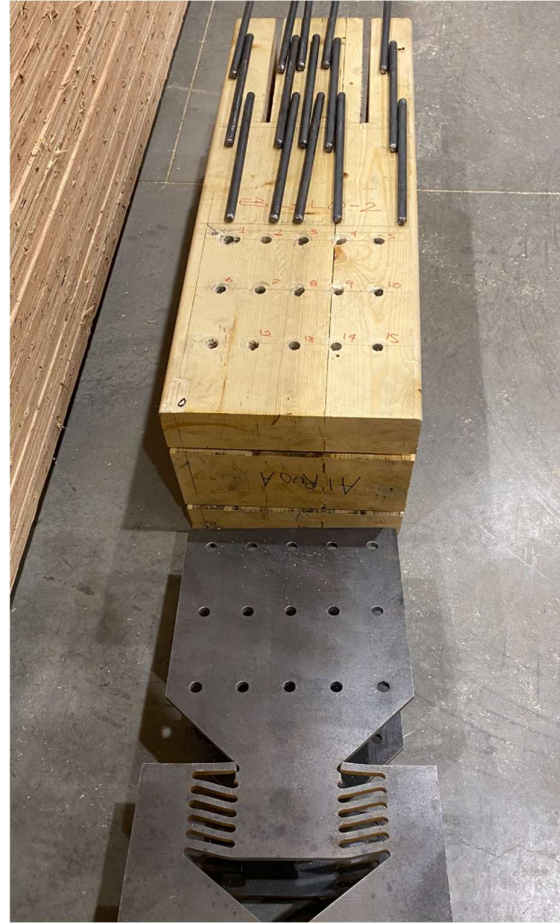
**Figure 6:** Resiliency in terms of replaceability

As illustrated in Figure 7, all damage was concentrated in the perforation zones. The capacity-protected steel dowel connections were undamaged and could be disassembled. The fuse end connection can be easily removed after the cyclic tests, representing the resiliency of the fuse with no damage to the timber component. To reliably design capacity-protected dowel-type connections, research to quantify the over-strength factor is ongoing.
